PERFORMANCE EVALUATION OF APPLE HILL ENERGY EFFICIENT HOMES

FINAL REPORT

CANADA MORTGAGE AND HOUSING CORPORATION

MAY, 1984

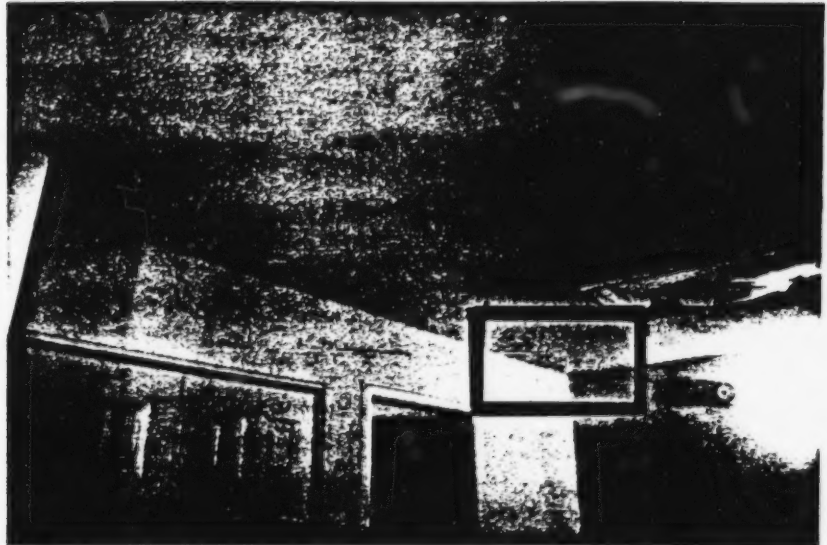
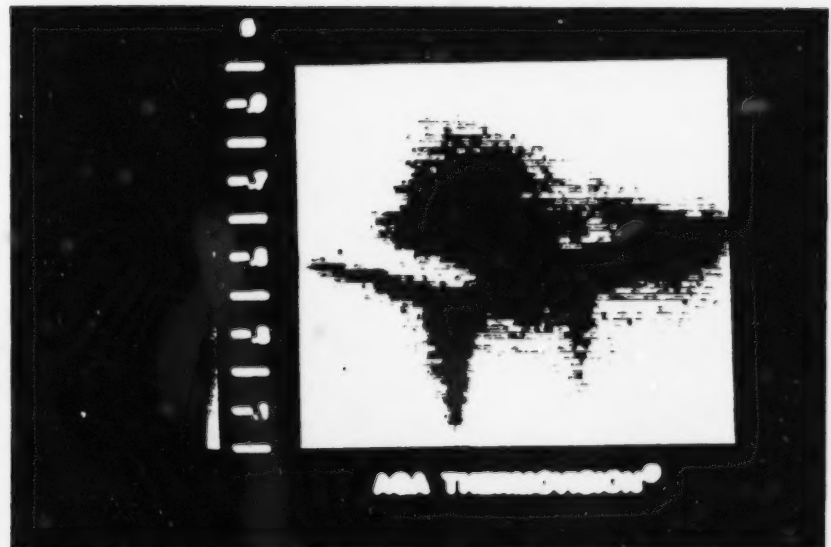
Second Floor Ceiling

Cold details in ceiling indicate possible air or condensation. The result of a poor A/V Barrier.

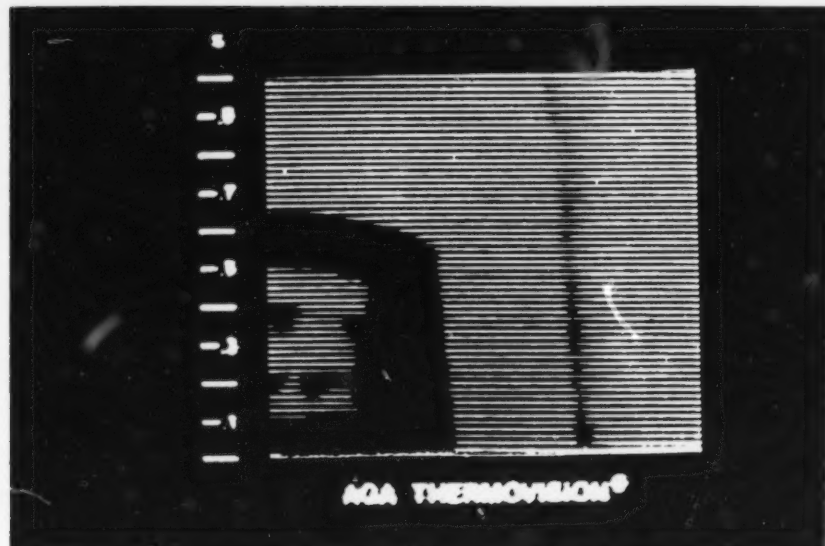
Figure 7.3

Air leakage at fireplace-wall joint, probably due to poor A/V barrier seal where wall meets fireplace

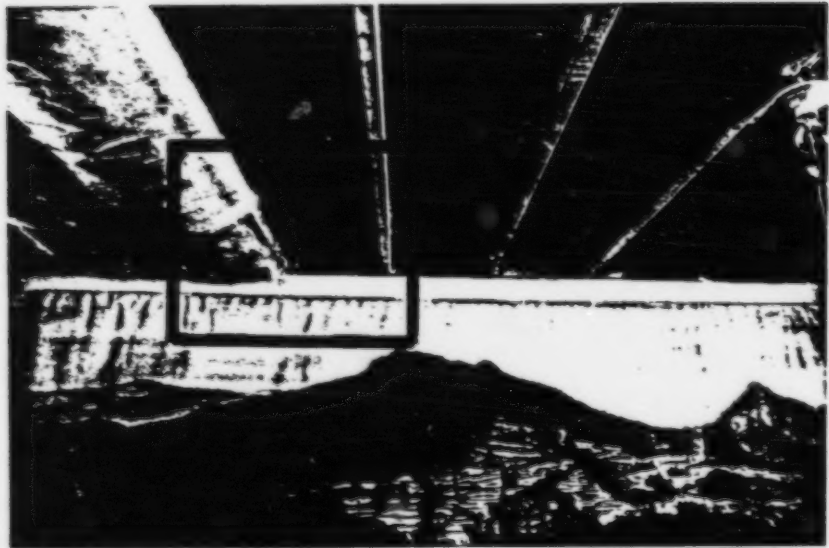
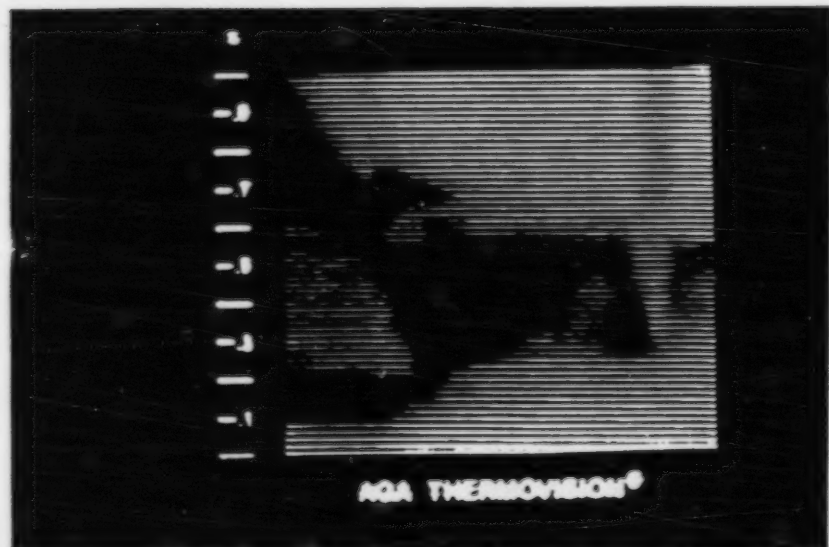
Basement Header

4. A major trouble spot on all of the homes was the header/joist area at the top of the foundation wall. A foam gasket was used underneath the sill plate which continues wherever there is rough concrete, window frames, plumbing or wiring penetration, ductwork, and partition walls at jogs and corners. The amount of air leakage into the finished wall cavity is such that all basement wall outlets and trimwork are very leaky.

Cold spots at insulated
vent and joist header
resulting from poor
A/V Barrier seal.

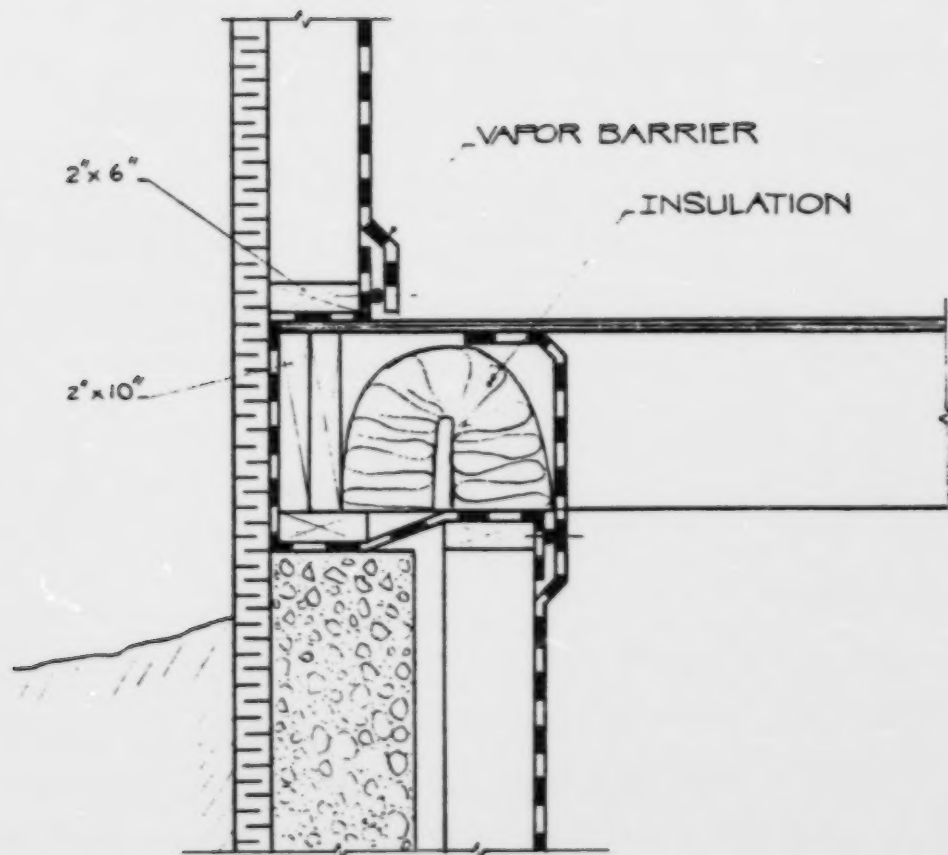
Cross Section of Header Joist

The difficulty of firmly attaching a polyethelene air vapour barrier along the joist/sub-floor topography should not be underestimated. The evidence of condensation problems along the header joist (band joist) suggests that a considerable amount of vapour is diffusing into this area. Any moisture that does reach the band joist is likely condensing, and has accumulated for several reasons:

A. The band joist is inadequately insulated with 37mm of glass fibre exteriors sheathing insulation;

C. The basement wall AV barrier is applied to the warm side of the header space fibreglass which creates partial vapour lock. This last condition requires immediate corrective action to maintain the integrity of the header joist. A detailed cross section of the header joist area is presented in Figure 7.5.
